Belcher Bits Decal BD36: RCAF Neptune 1/72

As early as 1948, it was recognized that RCAF Lancaster 10 MRs would need to be replaced in the maritime reconnaissance role. In 1952, the RCAF issued a requirement for what was to become the Argus but realizing delivery would not come soon enough, ordered 25 ex-USN P2V-7 Neptunes in 1953. They served from 1955, lasting until 1968 and were operated by 2(M) OTU, 404, 405 and 407 Squadrons.

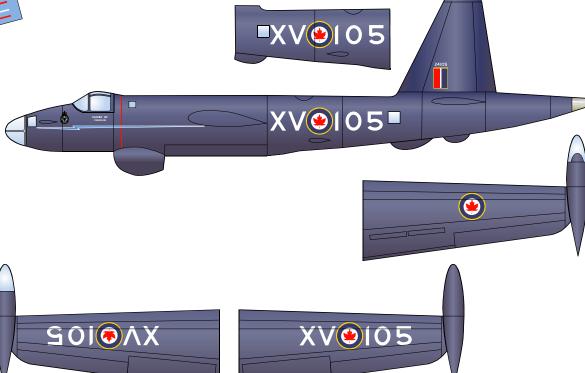
Neptune, s/n 24105, 2(M) OTU, 1956

This represents the delivery scheme. The airframe was overall Gloss Sea Blue. Yellow-bordered 48" roundels on fuselage, upper and lower wings. Squadron codes and last 3 of the a/c number were in 36" white letters. Squadron codes were XV (2 OTU), SP (404) and VN (405) ... 407 Sqn also operated the Neptune with code RX; this is not included on the sheet but could be made from a P and N if desired. 2 OTU aircraft had a white-bordered blue flash as shown, and MARITIME AIR COMMAND in small white letters below the canopy. On the tail was a red/white/blue flash, with serial in 6" numbers above. The tip of the MAD boom is unpainted fibreglass. Wingtops had 48" roundels, centred 34" out from end of ailerons, while under the wings were the codes and last-3 in 36" letters. Under the starboard wing, the letters AND the roundel were oriented to read from the rear.

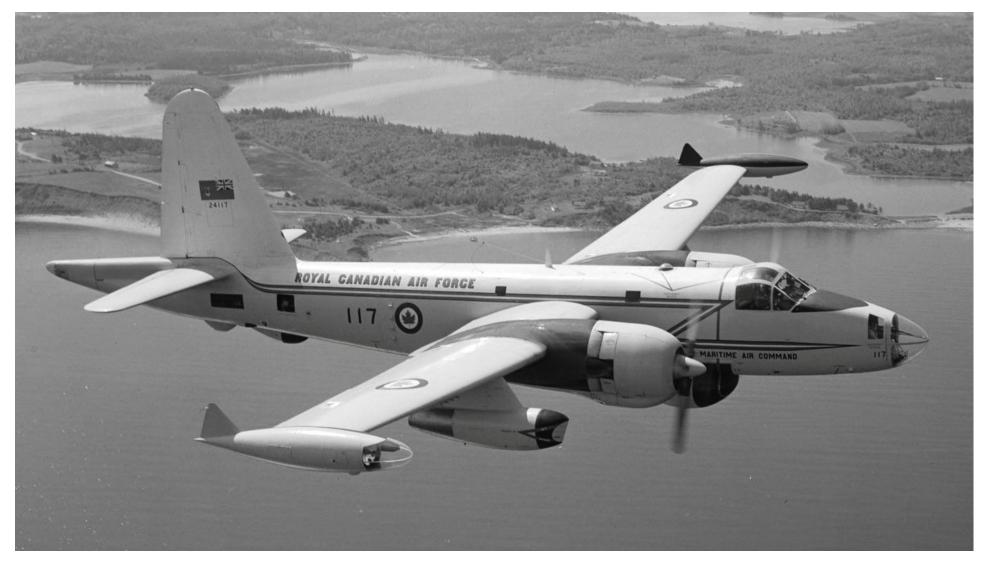
This shot, grabbed from the internet and credited to RCAF Photo, shows several pertinent points. First, notice how the fuselage flash needs to be cut away slightly at the wing root, and how the flash covers the prop warning strip. Also note the black painted areas behind the engines (top and bottom of the wing) and the shape of the anti-glare panel ahead of the cockpit. Finally, that black rectangle under the tailplane is, I believe, to cover exhaust staining from a rear fuselage mounted APU, and is present on both sides of the aircraft.
