GRUMMAN DE LA COMPANION DE LA

VF-15, USS Essex, CV-9 5 November 1944

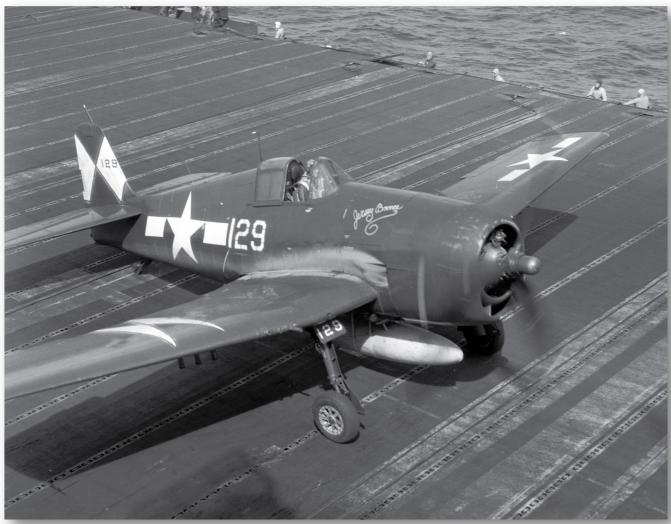
Photo: USN

"Jersey Bounce" taxies forward aboard the Essex in the spring of 1945. Points to note are the overspray around the geometric symbols (2" masking tape was used), the early white belly tank, and the characteristic F6F dusty grey-brown tetraethyl lead deposits. Her gear struts appear to be Gloss Sea Blue, with painted aluminum hubs. She has a fair bit of rash on her cowling leading edge and a little bit on the wing and stabilizer leading edges.

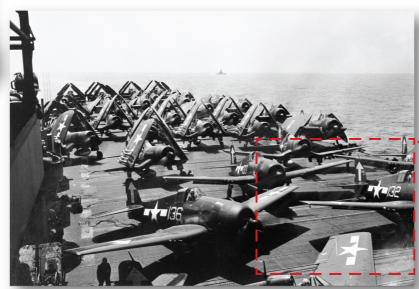
VF-84's F6F-5Ps wait their turn aboard Bunker Hill in mid-1945. Our subject is partialty off camera to the right, but many details are readily visible. Note the slight mismatch in the position of the number "1" in the side number, the lack of 5" HVAR stubs, and on the aircraft in the foreground, the photo sighting marks on the upper left wing. Also note the lack of paint chipping and the generally good appearance of the aircraft, with only some exhaust staining marring the glossy finish. By the time of this photo, the cowl numbers had been overpainted with fresh Gloss Sea Blue when the yellow, then white cowl ID markings were ordered removed.

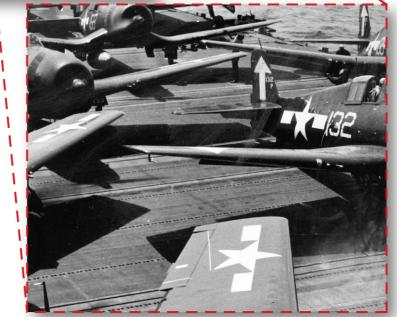
132's sister ship is airborne over the fleet. Note her lack of a left side oblique camera mount and the associated upper wing sighting markings. We believe this type of F6F-5P had a lower fuselage trimetrogon mapping camera mount as some F6F-3Ps did. but we have not been able to find absolute proof of this. Note the high gloss finish and the general lack of weathering other than the brownish-grey (tetraethyl lead) exhaust staining.

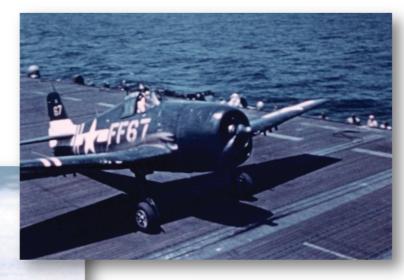
Four stills from some 8mm motion picture film of FF67 during mid-1945. Note that the yellow markings, especially visible in the photo at left, do not appear to be really bright, saturated yellow, but rather dull, as if the yellow paint allows the Gloss Sea Blue camouflage to show through somewhat. Also note that the wing stripes do not cover the leading edge of the flaps, meaning the stripes were applied with the flaps retracted.

Also note that the non-skid walkways on this aircraft appear to be very dark grey, unlike the earlier F6F-5s which had much lighter grey walkways. There is minimal exhaust staining, and the aircraft is overall very well kept. VMF-351 entered combat in mid-May 1945, so there was not time for its aircraft to get really grungy before the war ended.

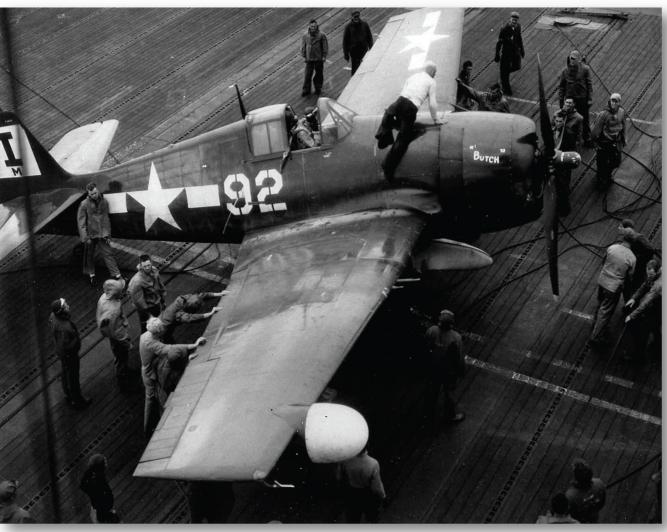
Photo: USN

A great shot of "Butch" being pushed forward after catching the barricade during mid-1945, Items to note are the 6x.50 cal armament (the 20 mm cannons were a rarity in the combat zone on F6F-5Ns), but note the conical flash hiders fitted to the exposed muzzles of the two inboard guns. Also note the lack of fishtail exhaust hiders - again the most commonly seen configuration on F6F-5Ns in the Pacific. She carries a white drop tank with the vertical flange. Her prop dome shows a bit of paint chipping, but aside from some dusty brownish grey lead deposits, she shows very little other weathering.
