F-4B/C/D/E/J

RF-4B/C/E

FACTORY STENCILS

F-4 Phantom Factory Stencils

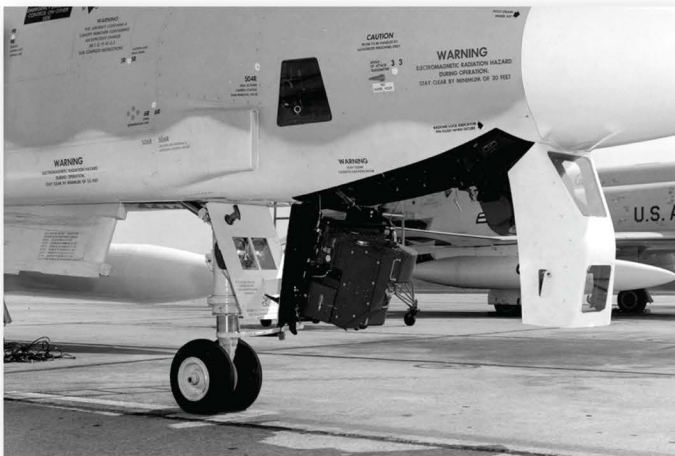
Left: an early RF-4C in the Light Gull Gray over white scheme on the ramp in St. Louis showing the white dots between or near the Access Door markings.

As if applying all these Access Door and Instructional markings wasn't enough (come on, you know you love it!), the vast majority of new F-4s left St. Louis festooned with white dots. These were final inspection stickers applied prior to handover to the customer, indicating that everything was ship shape. As you can see in these photos, the dots generally correspond with the Access Door markings, often being applied between the two numbers, or at least somewhere near them, overlapping the removable panel and the skin next to it.

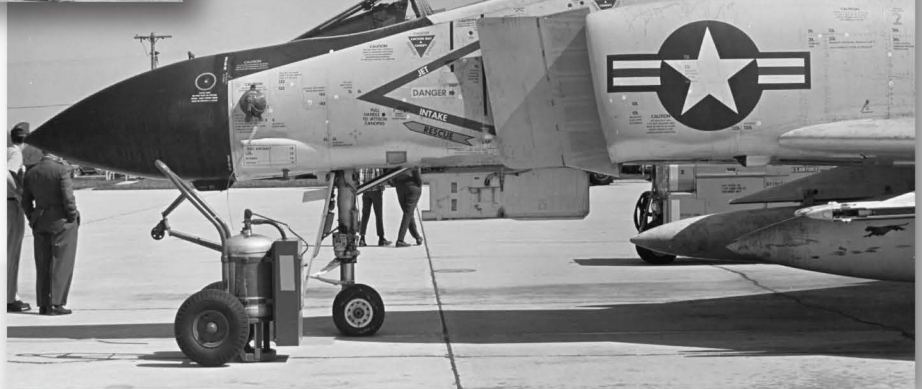
Below: an in-service F-4J from VF-121, still covered from stem to stern in white dots.

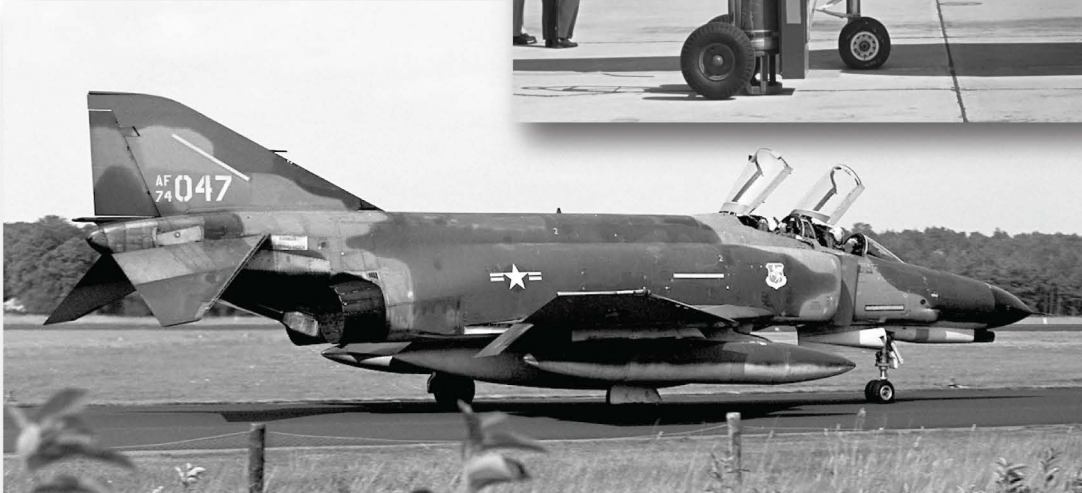
Below: a late production F-4E-60-MC wearing her full factory camouflage and markings. She has some white dots, but is not covered with them as was seen on many aircraft. We can't explain the difference.

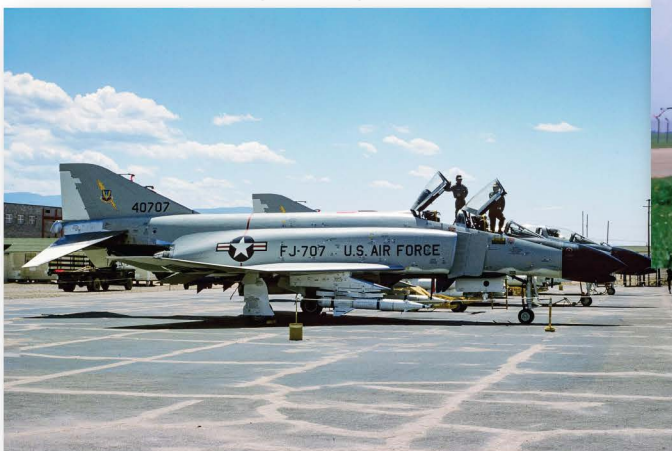
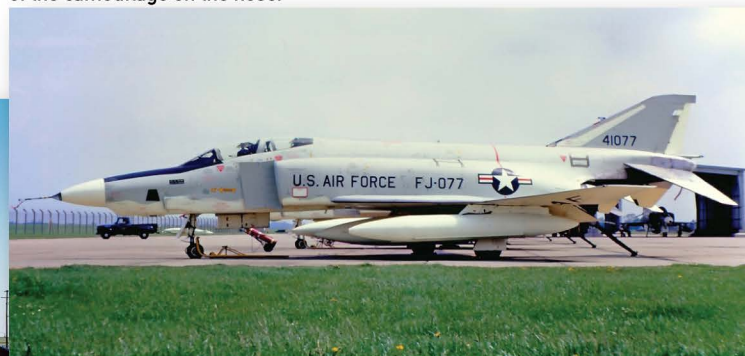
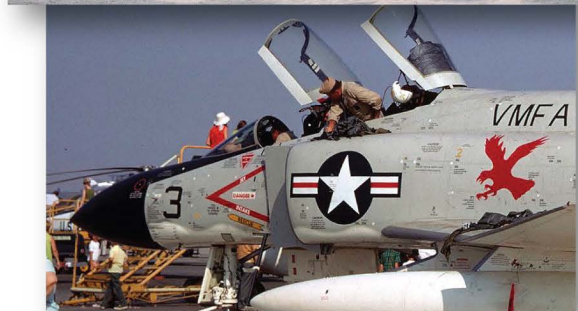
F-4C 64-0707 on display. Note the plethora of white inspection dots, and the very visible "pie wedge" of Corogard above the exhaust nozzle.

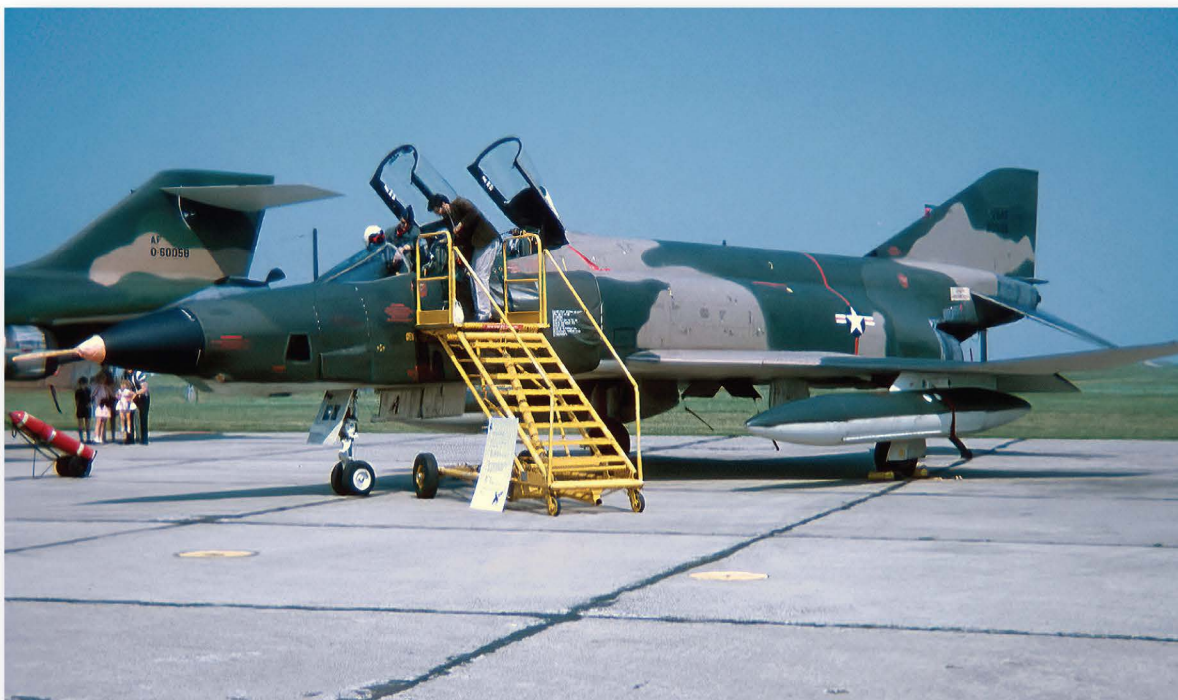
A spectacular shot of RF-4C-38-MC, 68-0565, taken at RAF Upper Heyford on 14 May 1969, *two days* after delivery to the USAF in St. Louis! Note the pale shade of tan compared to the RF-101 next door - absolutely characteristic of fresh McAir camouflage paint. Also note the bright red (vs. salmon) warning stencils around the nose.

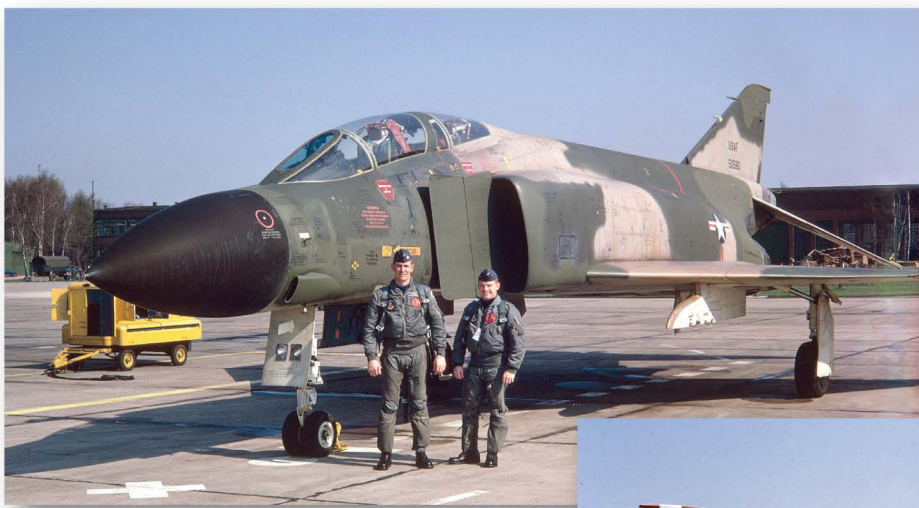
F-4D-26-MC, 65-0580 was delivered on 27 May 66, and lost on 24 Apr 67, less than a year later. She served with the 36th TFW at Bitburg AB, Germany where the weather was nowhere near as harsh as Southeast Asia, yet she is already faded, chalky, and has been touched up in several spots.

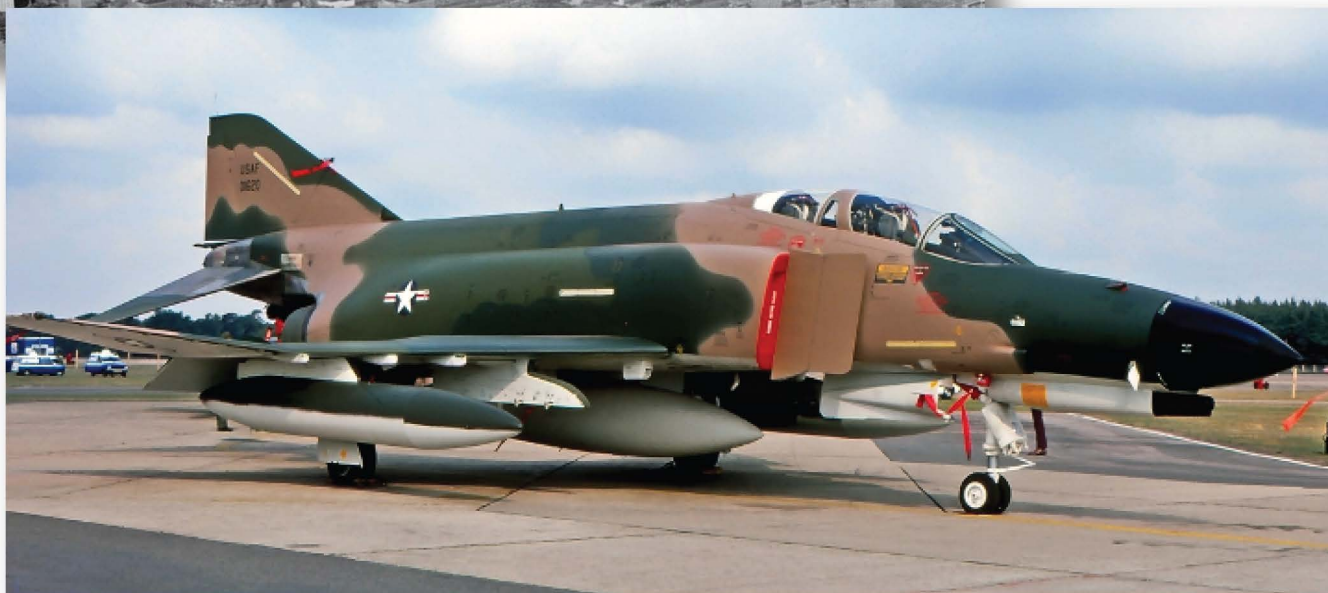
A late build F-4E-61-MC, 74-1620, delivered 6 Jul 76, is seen absolutely factory fresh and pristine, with no unit applied markings. Note that the pattern is unchanged since 1965, but these later aircraft were finished with paints that much more closely matched the FS595 standards. White dots have disappeared, though we have seen other contemporary aircraft that had them, so check references. Also note the use of the bright red warning placards around the cockpit in place of the 'salmon' versions. Also note the misting of green and tan paint over the hook warning placard, as well as over the rescue and ejection warning placards below the cockpit.

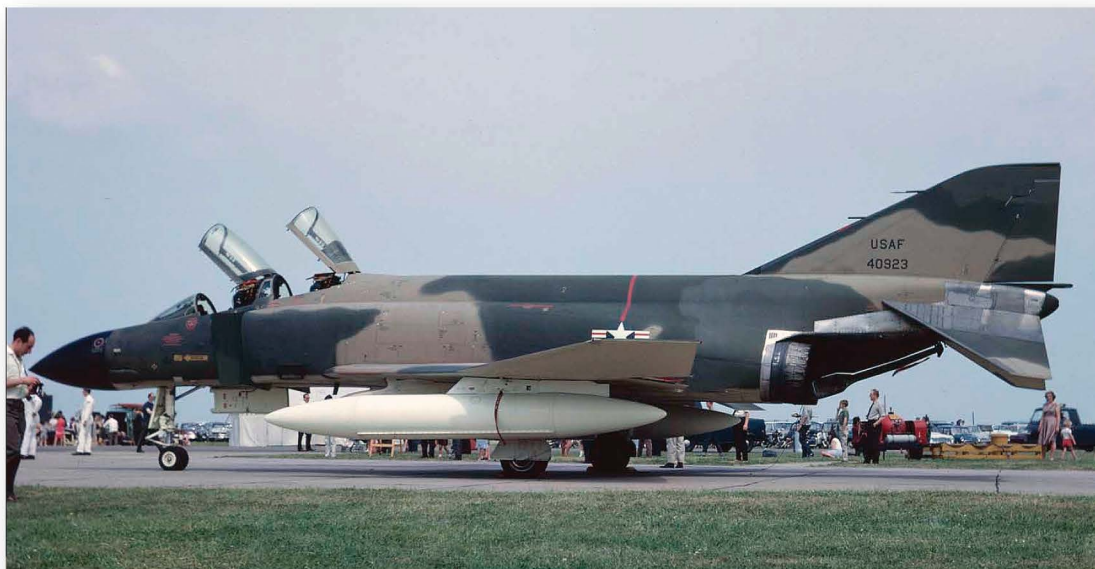
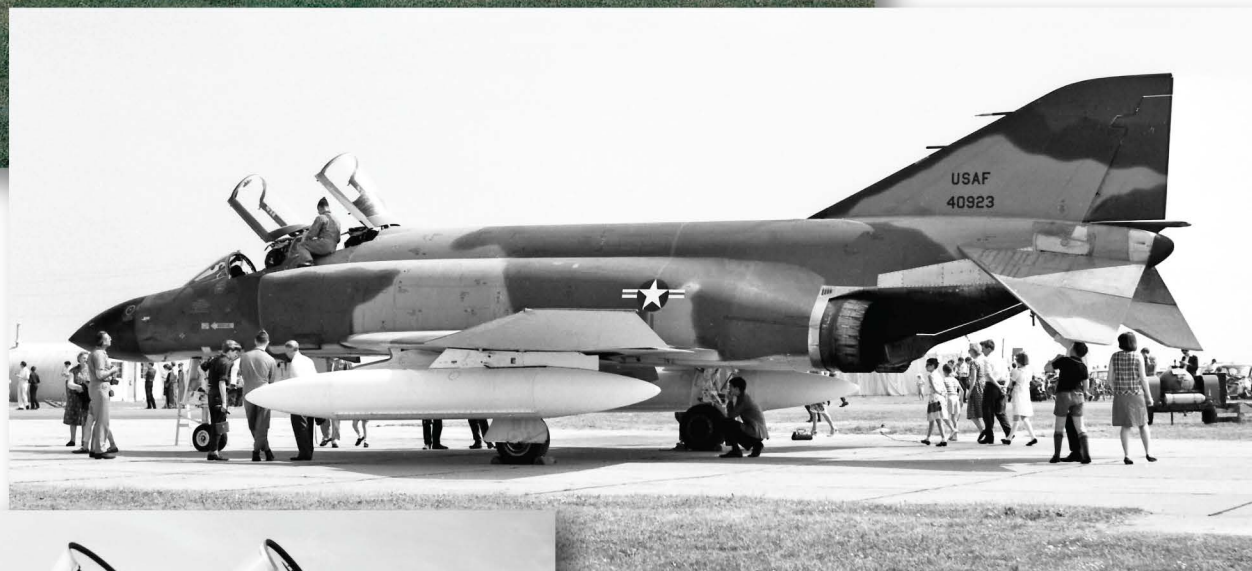
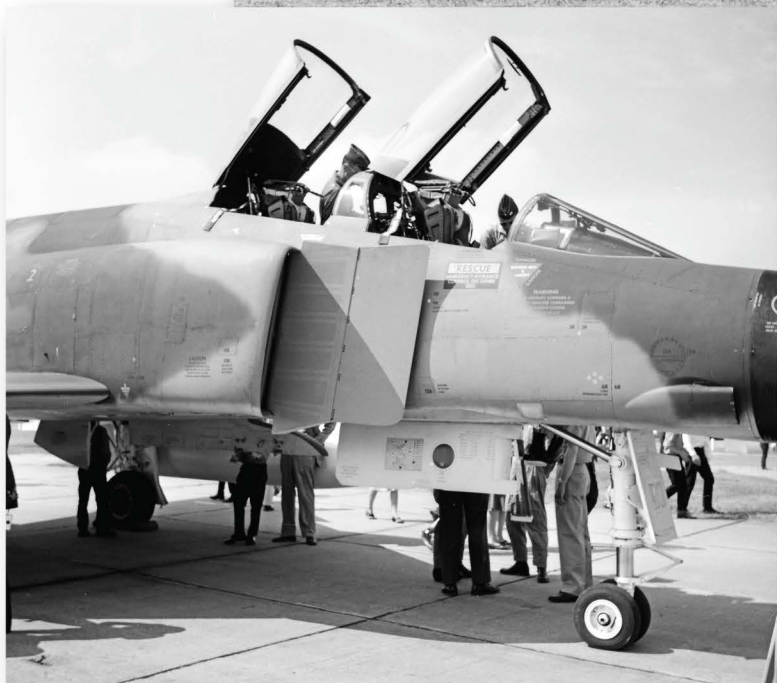
A trio of drop-dead gorgeous photos of F-4C-25-MC, 64-0923 (delivered 2 Apr 66), only five ships removed from the last F-4C produced, taken at the RAF Wethersfield, Essex open day in 1966. Lots of white polka dots everywhere. Note the dark colored blackout shade folded up inside the WSO's canopy - something every F-4 from first to last left the factory with, though the vast majority were yanked out as soon as the aircraft was delivered. Also note in the shot at left the round access door 124, indicating the aircraft was not equipped with the KY-28 secure voice system. Note how the FS 34079 curves down across the ECS inlet to touch the light grey belly - something almost completely exclusive to McAir factory camouflage. Note the black painted translating ring on the exhaust nozzle, but natural metal inboard stabs, as well as the FS 34079 painted drag chute door.

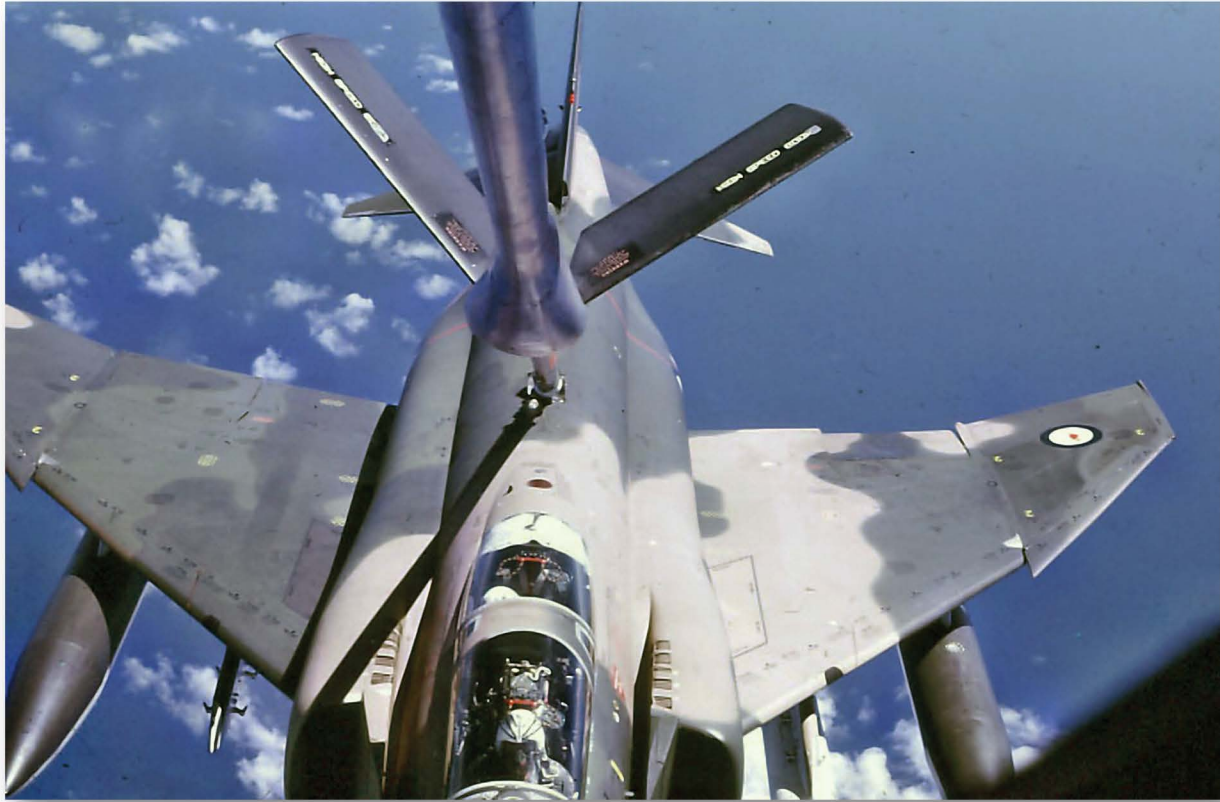
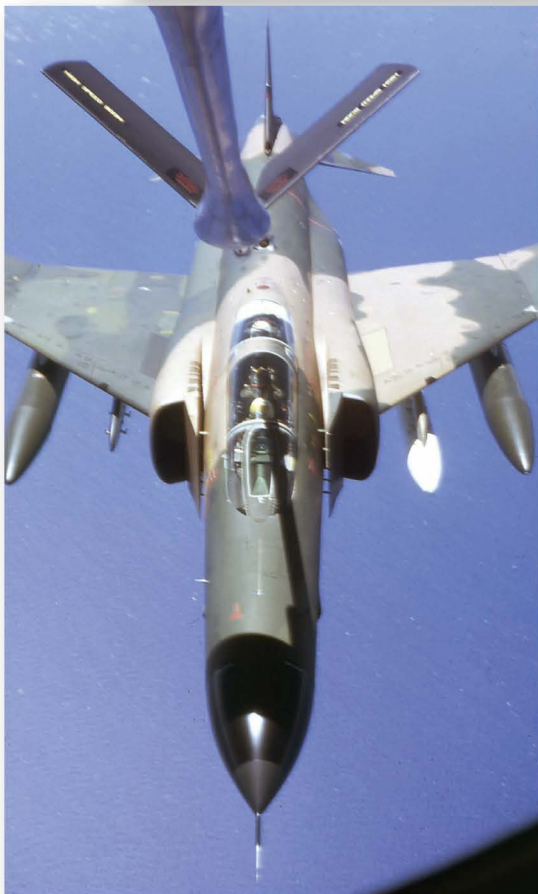
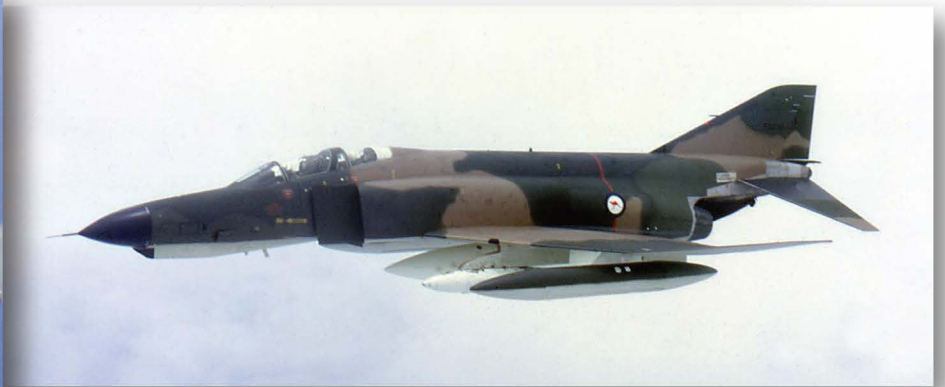
A fantastic series of photos of an RAAF F-4E on its delivery flight to Australia in 1970. Many items to note here! Note the difference between the color of the FS 34079 on the wing and that on the top of the drop tank. The McAir paint vendor's paint was lighter and chalkier looking, even when new. Note the darker appearance of the Corogard paint inside the right hand walkway vs. the lighter appearance on the left hand side. Note the rather 'fussy' demarcations compared to most depot repaints. Note the natural steel BLC exhaust outlets. Note the extra thin fiberglass piping around the canopies. Note the blackout curtain folded up in the back of the WSO's canopy. These were originally black, but later white. Note the full stencils but no white dots visible.

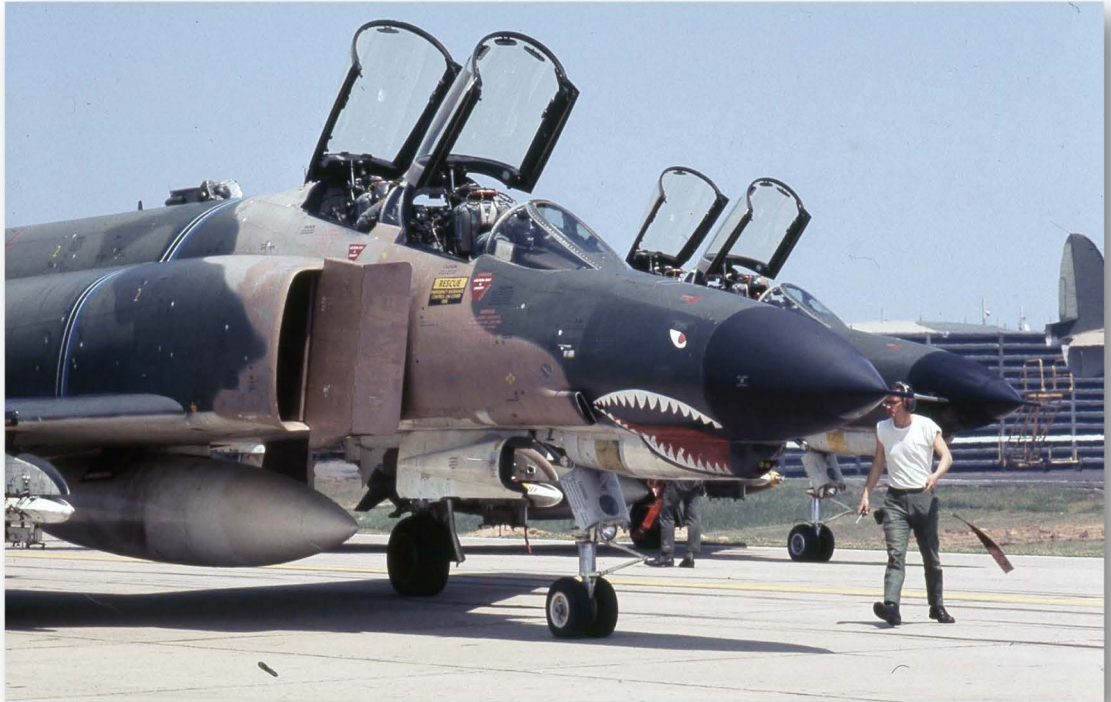
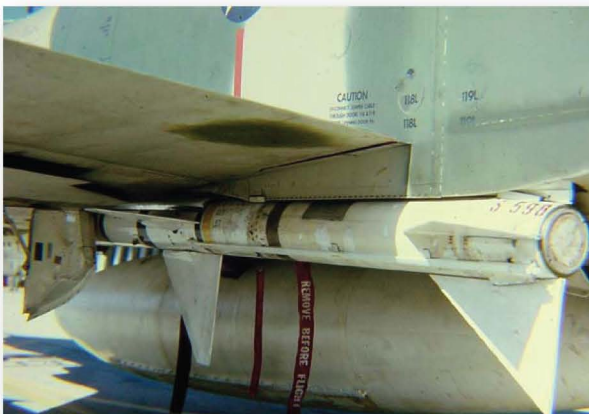
An early build F-4E in Thailand showing the full 'polka dot' treatment. She's had some mismatched camouflage touchups, but this is her basic factory camo. Note how quickly the McAir paints chalked and faded in the Asian weather. Note also the 'salmon pink' warning placards and "DANGER" titles around her ejection seat warning triangles.

A tight closeup showing how the 118/119L and R access door stencils could be at the bottom or the top of the circular doors, depending on the whim of the person applying them. Also note the color demarcation brought straight down from the trailing edge to the chine along the edge of the aft Sparrow well. Note that the red turbine warning stripe never touched the blue disk of the insignia. There was an approximately 2" gap on both sides. This aircraft has had some corrosion control touching up, but it is still in its overall factory finish.

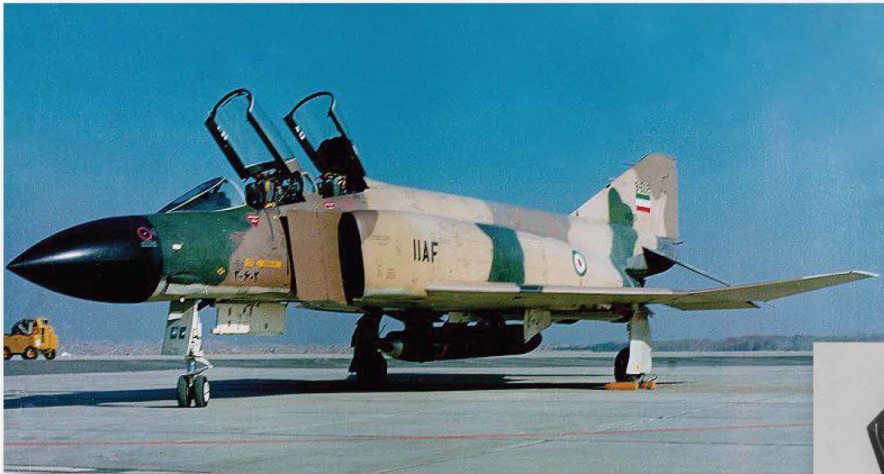
Left: F-4D-35-MC 67-14870 (3-602) delivered 4 Sep 68. Iran became one of the major export customers for the F-4, and the only non-US customer for new build F-4Ds. Most were delivered with 'slick' radomes, and all were finished in the "Asia minor" camouflage scheme - unique among all F-4 users.

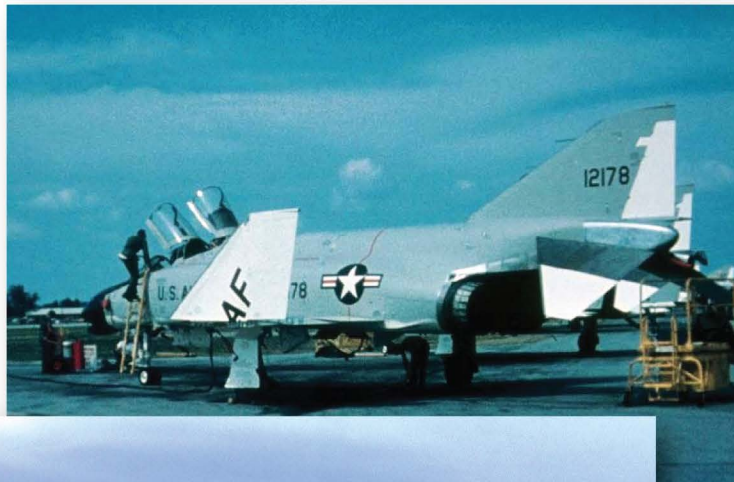
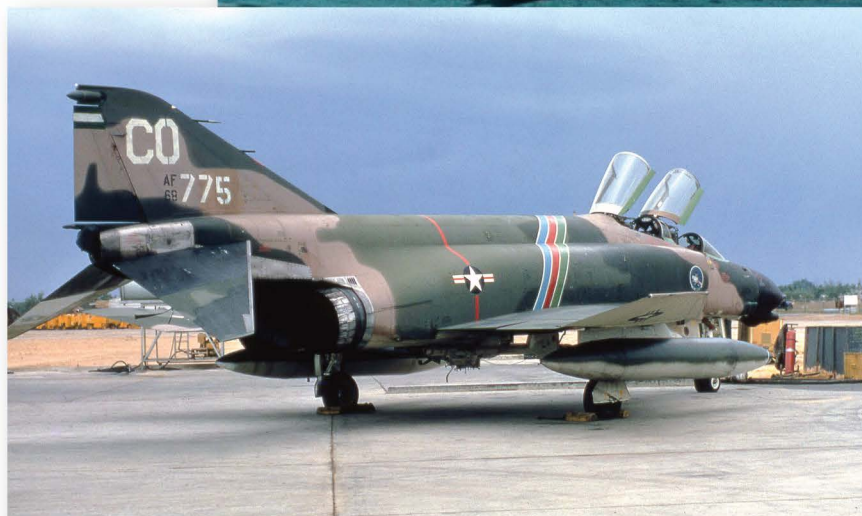
One of the 27 borrowed F-4Bs used by the 4453rd CCTS at MacDill in 1962-63, showing the black translating ring.

F-4D-32-MC 66-8775 in her factory paint, again illustrating the glossy black translating ring and inboard stabs.

Something that had escaped our notice prior to this project was the black painted translating afterburner nozzle ring (forward of the petals). On all new J79s installed on new F-4s the ring was glossy black, right from the very first J79-GE-1s installed in the prototype F4H-1s. When you start looking for it, it's there every time. As the ring moved back and forth, it sometimes got scraped up, and sometimes the paint would flake off, but the paint was there. This carried forward through F4H-1/F-4B production, as well as on all USAF "short burner" aircraft (F-4C, D, and RF-4C) until at least the early 1970s.

Then we started noticing aircraft with glossy black inboard stabilizers - wait, what? A lot of research later, we're pretty confident in saying that (almost*) all F-4Ds and RF-4Cs beginning with Block 26 (the first FY65 serials), as well as all F-4Es up through somewhere around the end of Block 44 (FY69 serials) had glossy black inboard stabs. Iranian F-4Ds (at least the Block 33 aircraft we have seen period photos of) also had black inboard stabs, as did the Australian Block 43 F-4Es. We have found no instance of a Navy F-4 with black inboard stabs.

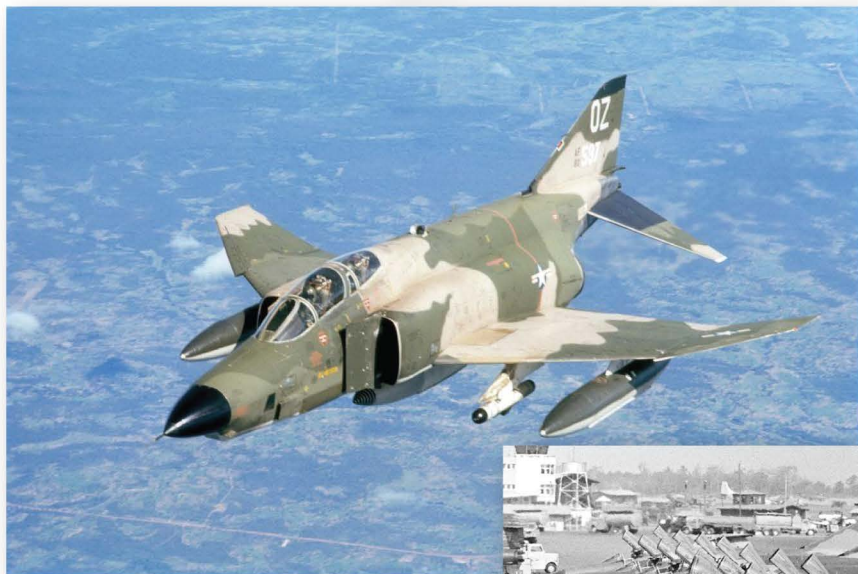
A pair of RF-4Cs showing the black inboard stabs.

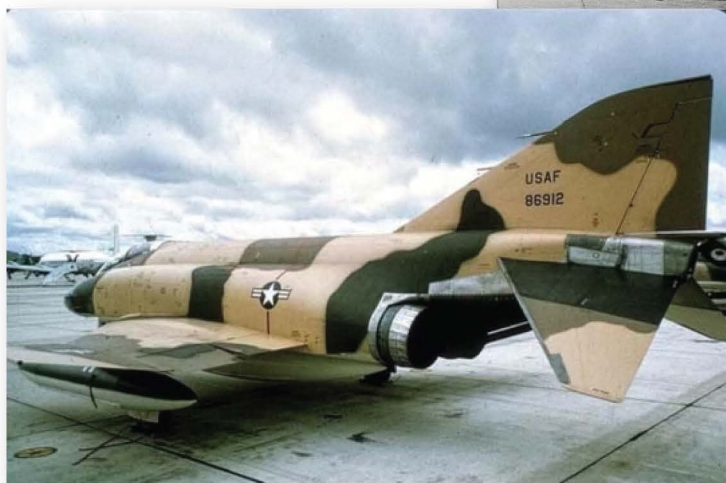
Two F-4Ds, one Iranian and one American. On F-4D-30-MC 66-7509 note how the black paint is chipped off on the inboard stab.

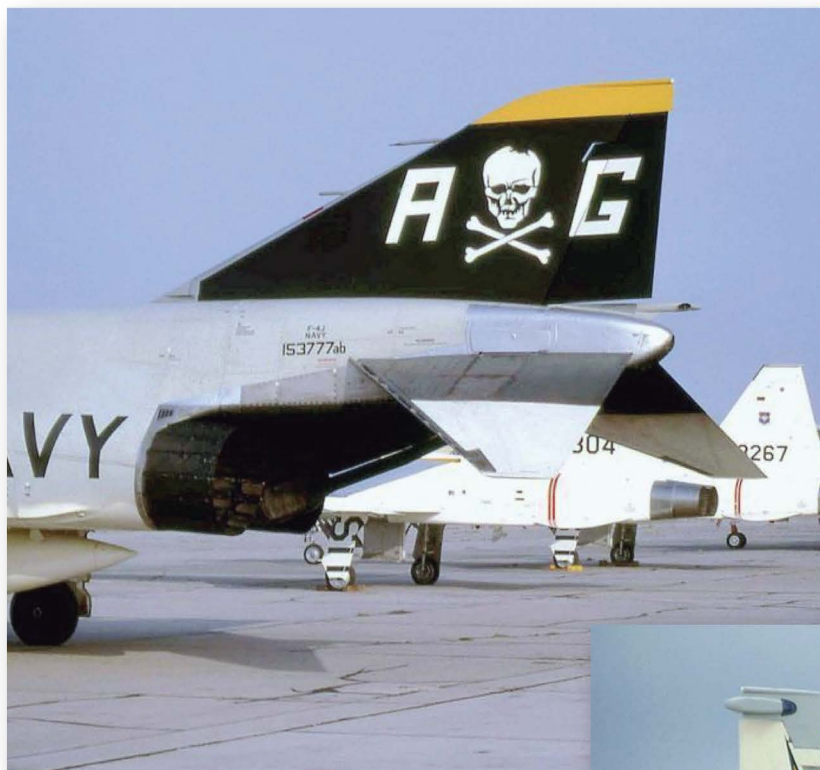
Two shots of early build (153777) and late build (158370) F-4Js. Note that the Navy never painted the inboard stabs glossy black, but the afterburner nozzles were.

Also note the Corogard paint above the stabs and on the drag chute door on early build F-4Js, with natural metal, with an FS 36440 drag chute door on later build aircraft.

So then we started looking at Navy airplanes and F-4Es with the long burner nozzles. And we saw glossy black everywhere on new F-4Es and Js. For certain, all Js were finished that way up to the last one built in late 1971, and all Es were finished that way up into the 1972 production blocks. We can't positively identify when they stopped painting the burner nozzles, but later F-4Es in the FY72 and later blocks had bare metal exhausts.

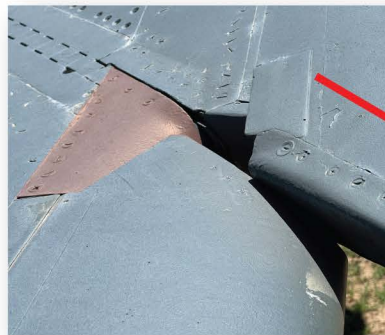
The left wing BLC exhaust on an RF-4C. This detail is identical on all hard wing F-4 variants (F-4B/C/D/early E/J/RF-4B/C/E).

On "hard wing" F-4s (which includes the F-4B, C, D, RF-4B/C/E, F-4J, and F-4Es through 71-0236) the leading edge flaps featured Boundary Layer Control (BLC). This routed high pressure air from the engine compressors through ducts along the leading edges to "blow" the flaps and create greater lift, allowing a slower takeoff and landing speed. The BLC air exhausted through these two panels at the outboard end of the leading edge flaps. From the factory these panels were in their natural stainless steel finish, though on depot repaints they were often overpainted. Tamiya again wins hands-down for the shape and detail of this panel. The real thing is curved allowing for the air to escape, and you can actually put your hand into the opening (if you're not afraid of spiders and scorpions). Zoukei-Mura's panel is flat, just like the surrounding upper wing skin.

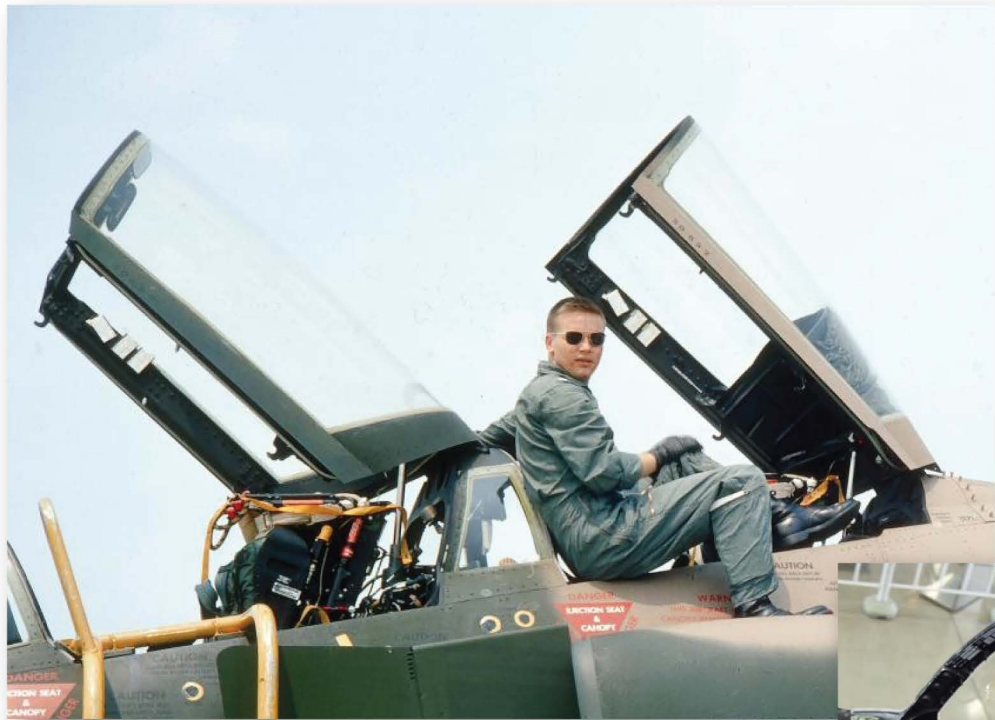
A collection of photos showing the raw fiberglass framing on the aft windscreen bow, the forward edges of the front and rear canopy, and around the center windows in the bow between the two canopies. Note that on the windscreen the fiberglass does not go all the way to the middle. It ends where the metal frame of the center panel joins. On some of these you can see the additional very narrow fiberglass that runs along the bottom and aft edges of the main canopies.

Decals W10 through W14 are the internal fiberglass sealant strips sometimes (but not always) visible. These are on the INSIDE of the canopy on the real aircraft, sandwiched between the frame and the plexiglass, but applying decals that way would be a real challenge... Just reverse the L and R decals if you want to try, and best of luck! We recommend cutting these decals into sections before applying them. There is plenty of extra black and buff colored striping to allow you to do any repairs necessary with any of these colors.

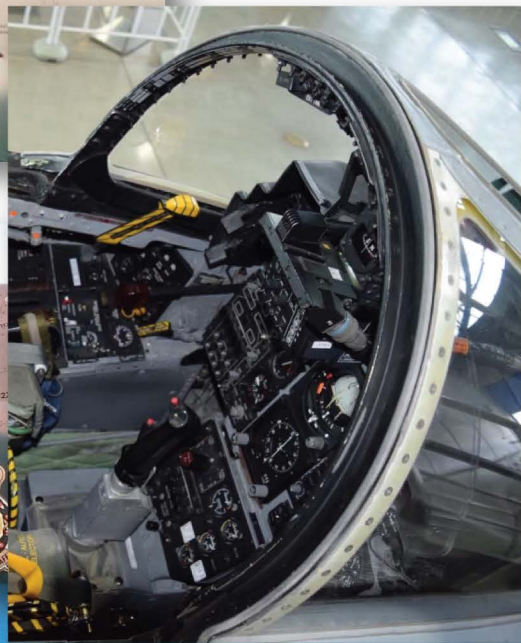
Right: A late find... A pristine F-4D with the more visible lower and aft edge internal fiberglass seal strips visible. These strips are on the inside of the plexiglass, though that is difficult to discern in most photos. This feature was seen on many, but far from all new F-4s. We do not know why that is the case, so the best we can offer is to look at photos of your subject and build what you see.

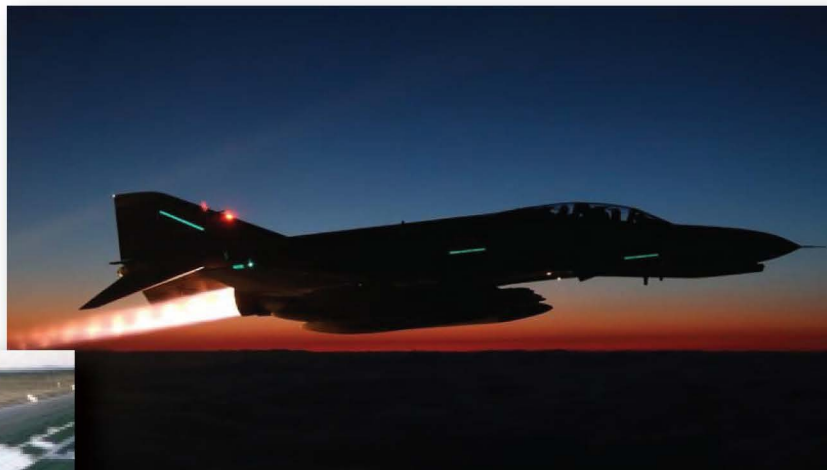
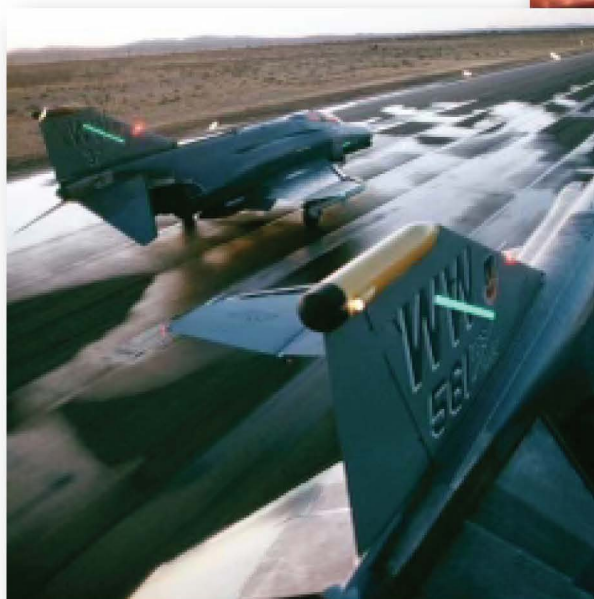
F-4 fuselage and vertical tail slime lights are mounted in a frame that stands proud of the skin of the aircraft by about 1/8" (approximately 3-4 mm), held in place with Philips head screws.

On the wing tip lights on hard wing aircraft, the frame holding the electroluminescent strips was set into the skin panel on the tip, while on almost all depot mods we have found, it completely fills that skin panel (see diagrams), and often appears slightly raised above the wing skin. The design of the wing tip lights changed completely when the slatted wing was introduced on the assembly line starting with F-4E-48-MC 71-0237. It appears there was an early version, found on aircraft at least midway through the FY72 production blocks (see photo next page), and a later version fitted through the end of F-4 production.

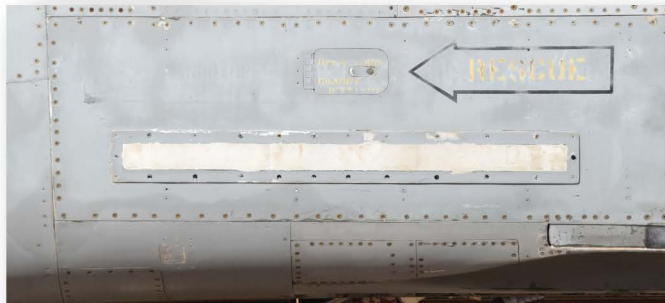
On factory installed lights, the mid-fuselage strips in Access Doors 36L and 36R were invariably mounted at a slight nose-down angle. Depot installed lights in this location could be seen the same way, while others appear to be parallel to the lower edge of the panel.

Left: the forward fuselage light on QF-4E-61-MC 74-1625 showing the slight raised frame.

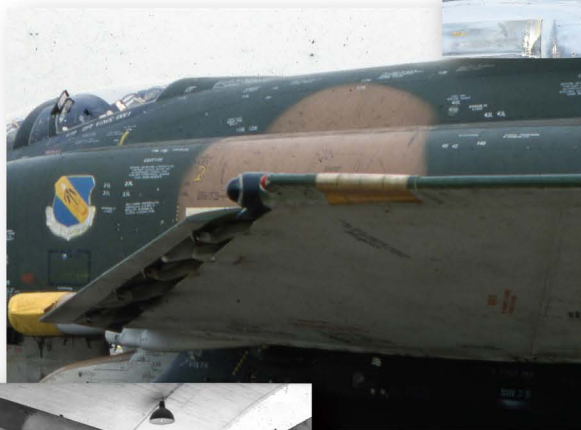
Left: the left wing tip light on F-4E-54-MC 72-1484 showing what we believe to be the early configuration of the slatted wing tip light. Note the brownish frame around the light.

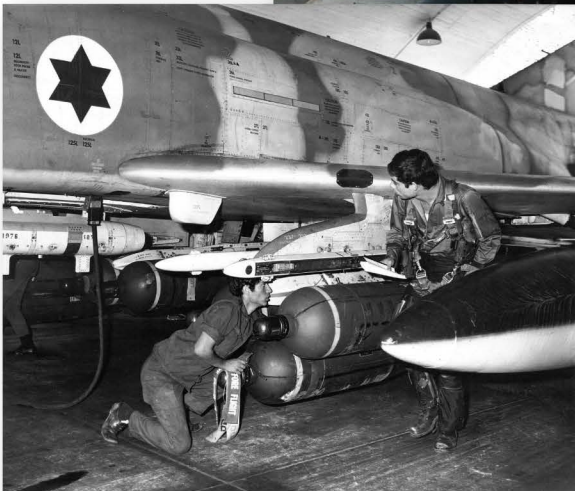
Below: an F-4F (identical with later block F-4Es) showing the more common style of lights. This aircraft lacks the black frame seen on many aircraft.

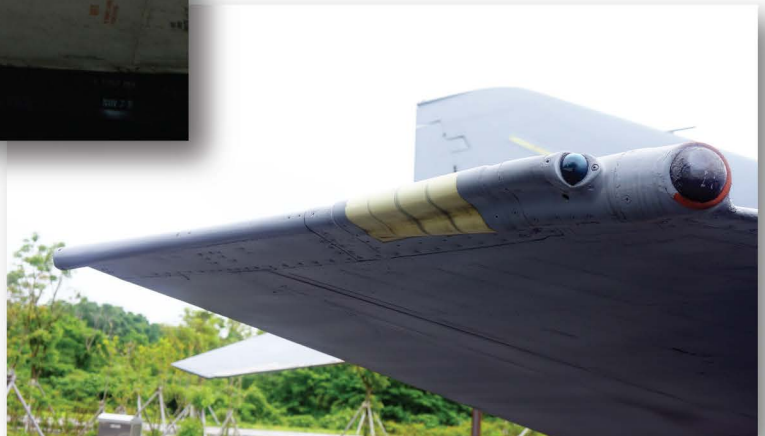
Left: a shot of an IDF hard wing F-4E with the narrow black framing around the light strips. These were often seen mixed with unframed light strips on the tail on the depot installed lights.

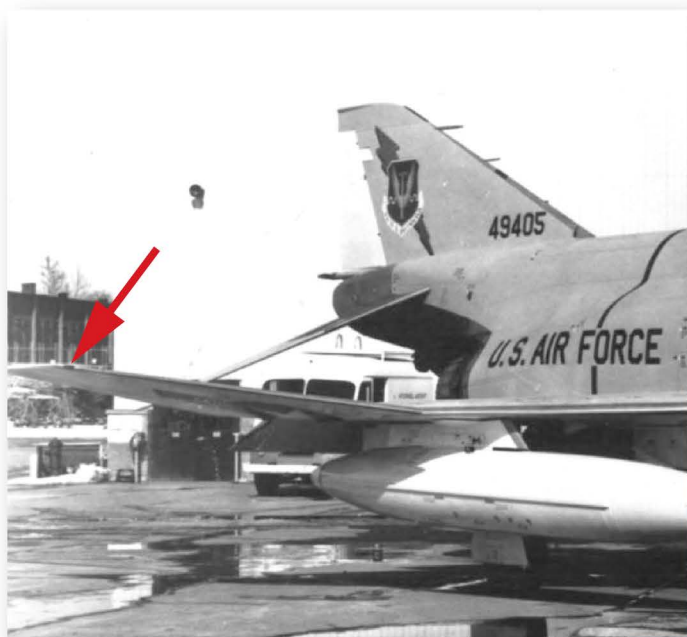
Left: F4H-1 149405 Block 9, alias F-110A is seen shortly after roll out in Jan 62. She has the original flush style nav lights.

Phellow Phantomaniac Kim Simmelink (in his terrific Phantom Phacts blog; <https://phantomphacts.blogspot.com>) notes three distinct styles of Phantom wing tip lights. The first style (not shown here) seems only to have been fitted on the very earliest airframes before the second style (shown at left) appeared. This was found on F4H-1s as well as early F-4Cs. It appears the change to the 'bug eye' style lights took place somewhere during Block 6 production on the F4H-1, but the picture is still very muddy. Since the first actual F-4C was a Block 15 airframe, and we have photos of quite a few early F-4Cs with the original style flush light, we're at a loss to explain how it came down. What we do know is that the 'bug eye' style was pretty rapidly retrofitted, and the older flush style seems to have disappeared, even on test birds, by somewhere around the end of 1964. This feature is often virtually impossible to discern in photos, but we have provided some below to illustrate the original style. For sure the two F-110As (BuNos 149405 and '406) as well as a significant number of actual production F-4Cs had the early style when they rolled out of the factory. More reseach required!

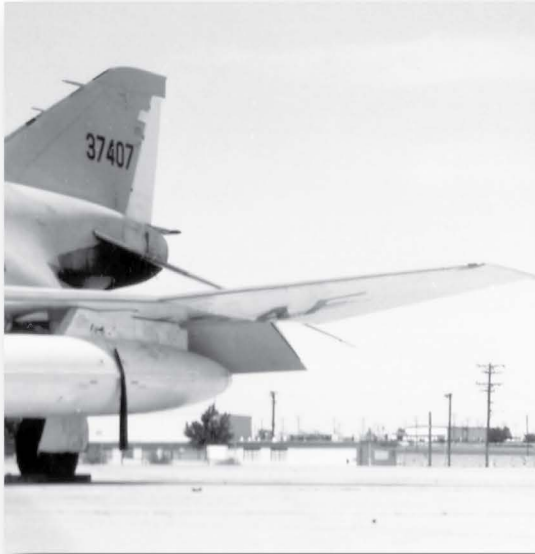
Right: F-4C-15-MC 63-7410 showing the flush style lights.

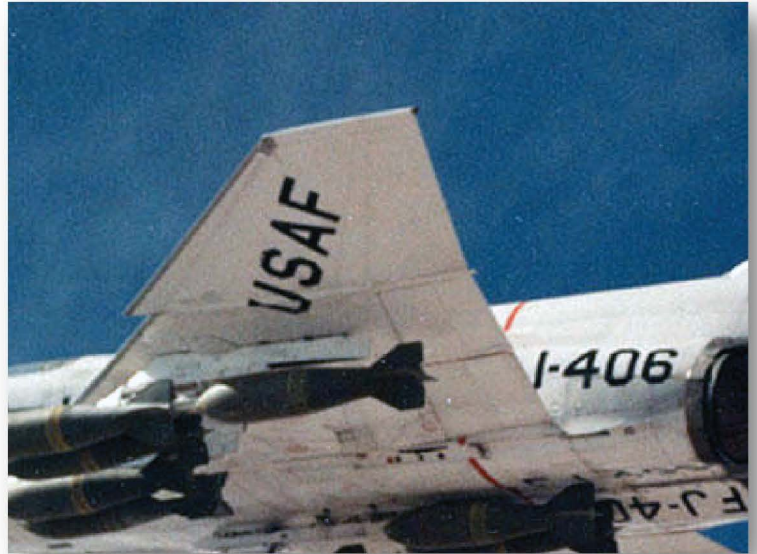
Above: F-4C-15-MC 63-7407 displays the flush style light shortly after roll out in Jul 63.

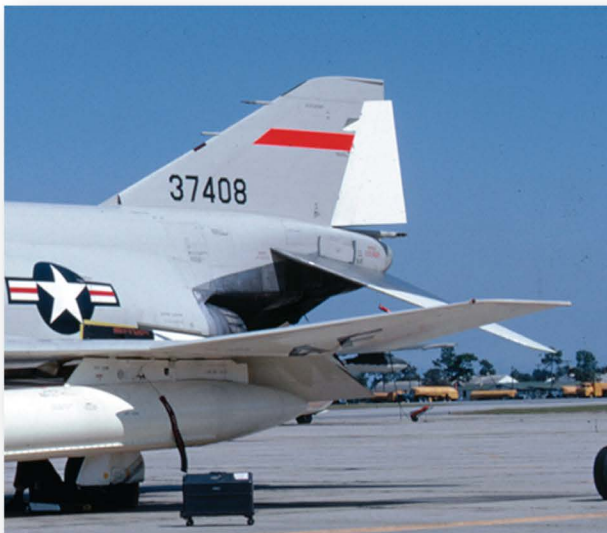
Above: We can't explain how F4H-1 149406 Block 9, here marked as the second F-110A prototype, got the later 'bug eye' lights as quickly as it did, but photos don't lie! This photo dates from the summer of 1962 during weapons compatibility testing.

Below: F-4C-15-MC 63-7408 photographed during 1965, now with the 'bug eye' style nav lights.

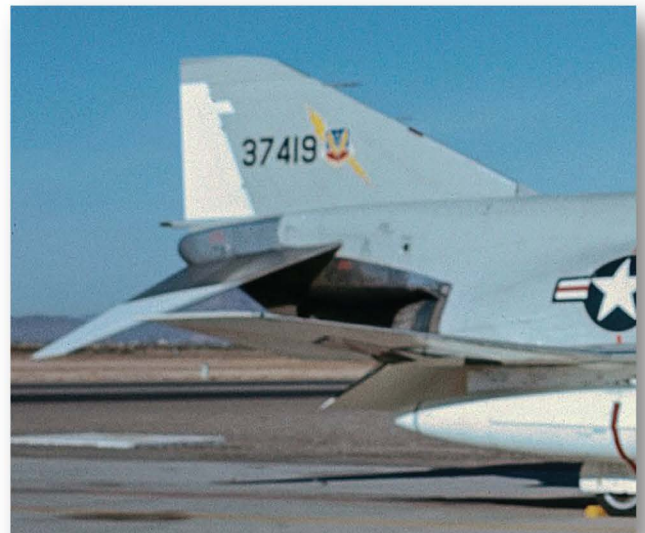
Below: F-4C-15-MC 63-7419, date unknown, also with the later style lights.

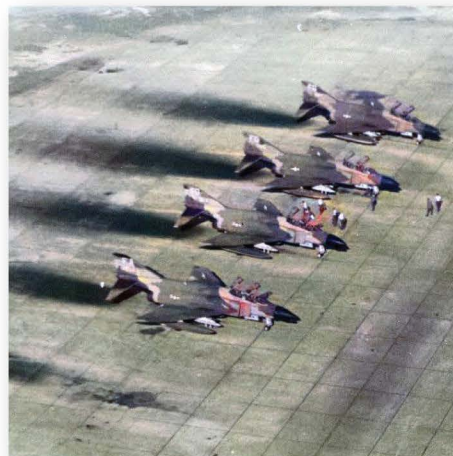
- The natural metal area behind the engines on Vietnam through 80s era Phantoms was *filthy*, with a heavy buildup of black and brown toned oily soot. It was not until the "smokeless" engines appeared in the 1980s that this changed. Most scale models don't portray just how dirty Phantoms were in those days, so for it with the soot! For 1990s and later (i.e., modern Greek jets) go nuts with the metallurgy experiments in different burnt titanium colors, after cleaner

“smokeless” engines were fielded in the late 80s, but a 60s or 70s jet is DIRTY. The concrete in the last chance pit at Udorn RTAB proves it!
